Date 19th July 2018

Progress repair of Ebridge Lock wall

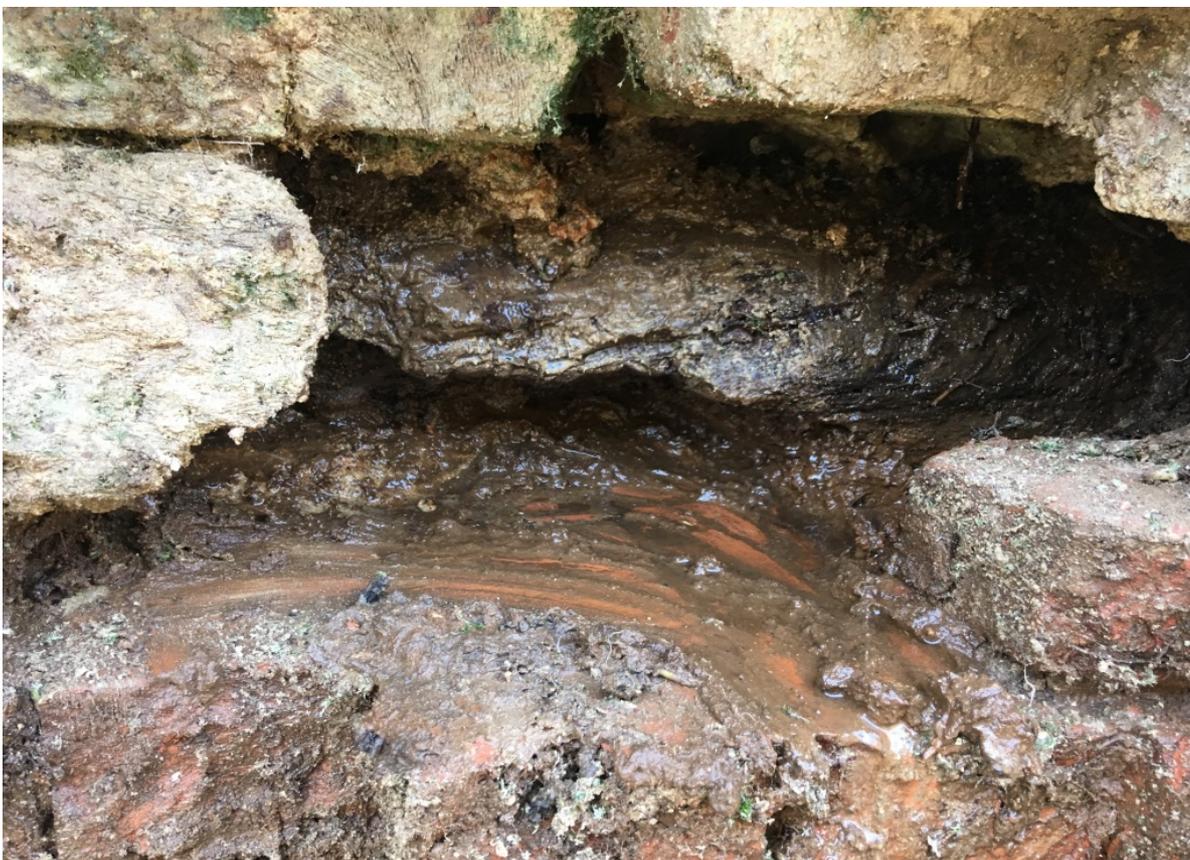
Area 1 - Horizontal timber parallel to lock wall face –some timber intact but significantly eroded.

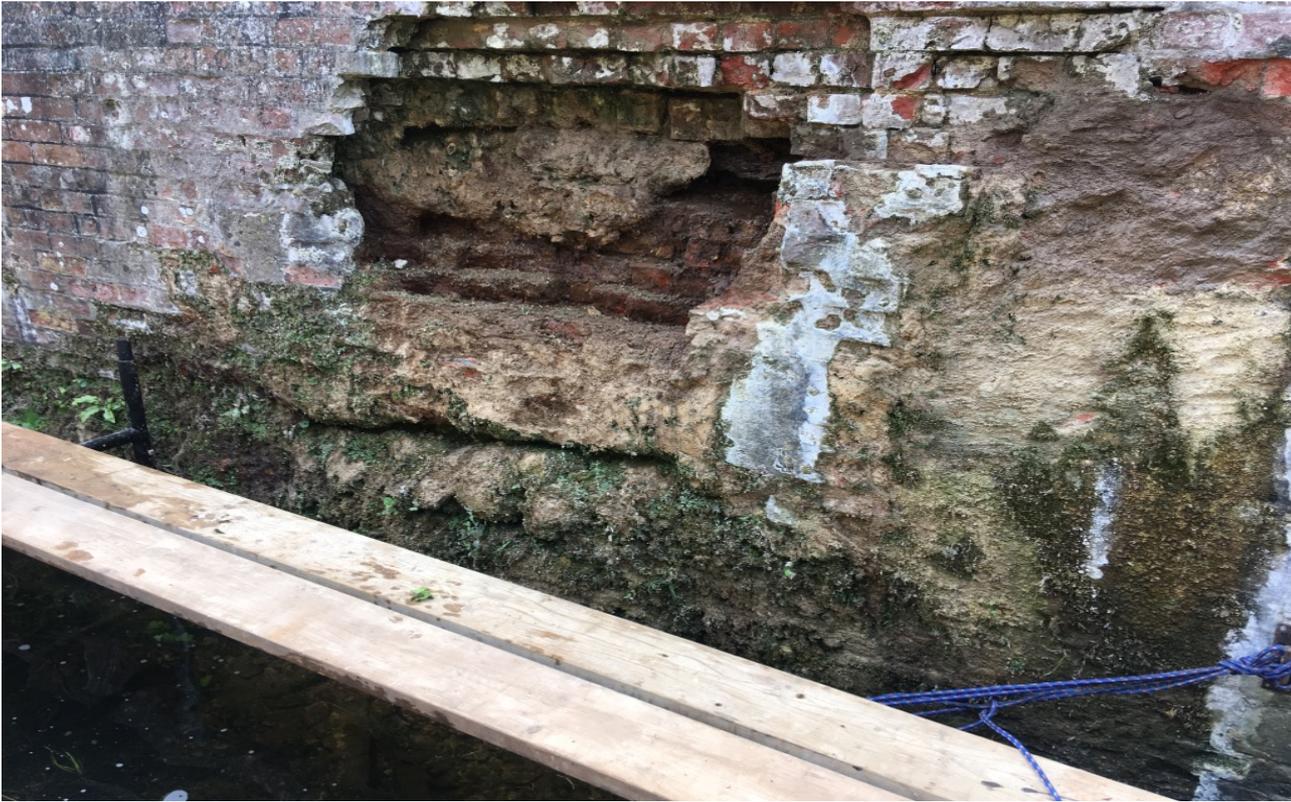
Area 1 – Rough mortar in centre of hole applied over where timber eroded but still some solid wood

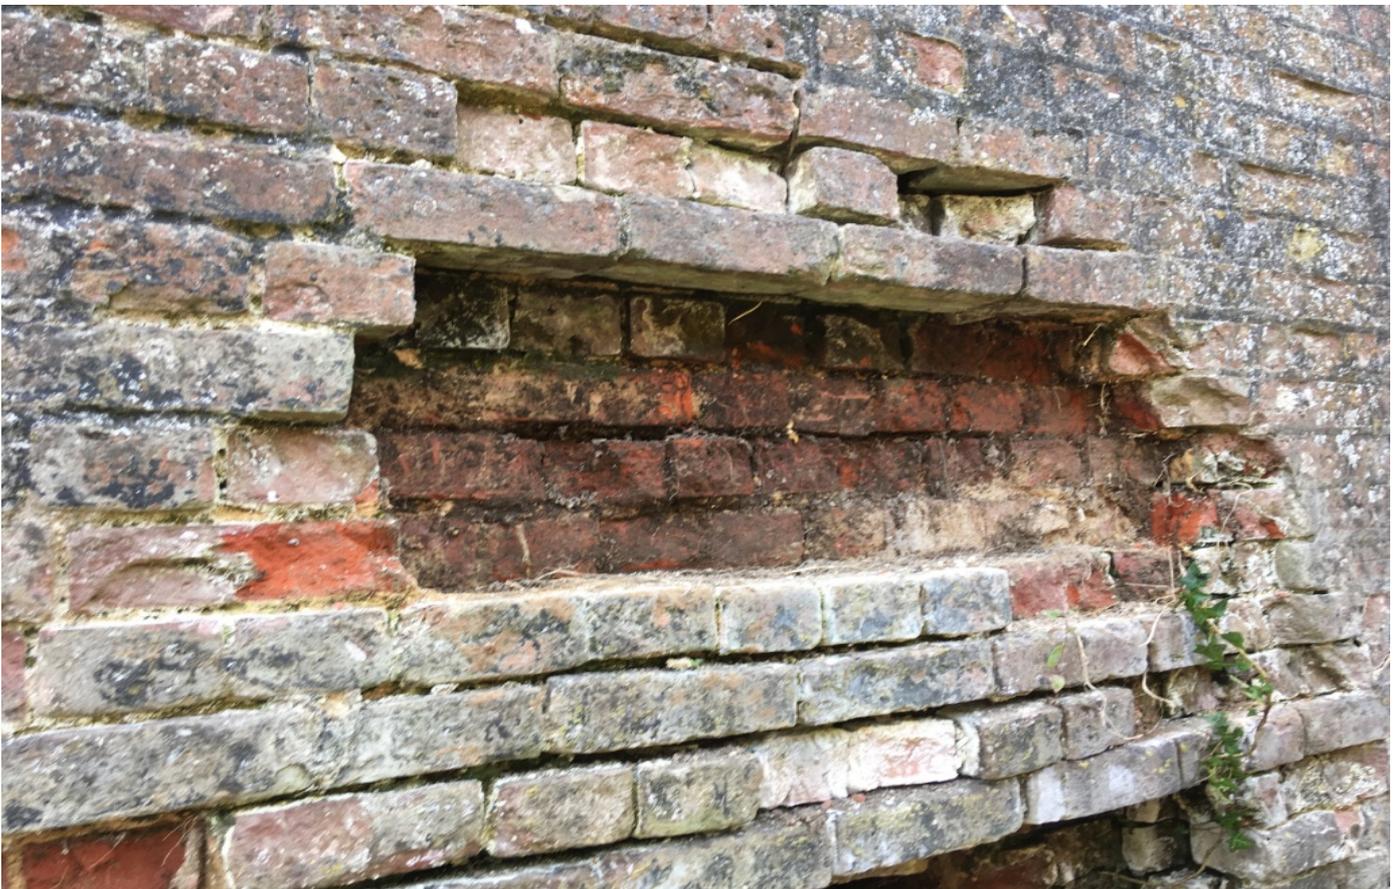
Area 2 – shows single brick facing (circa 1900?) over what appears to be undamaged original canal wall face – no ties

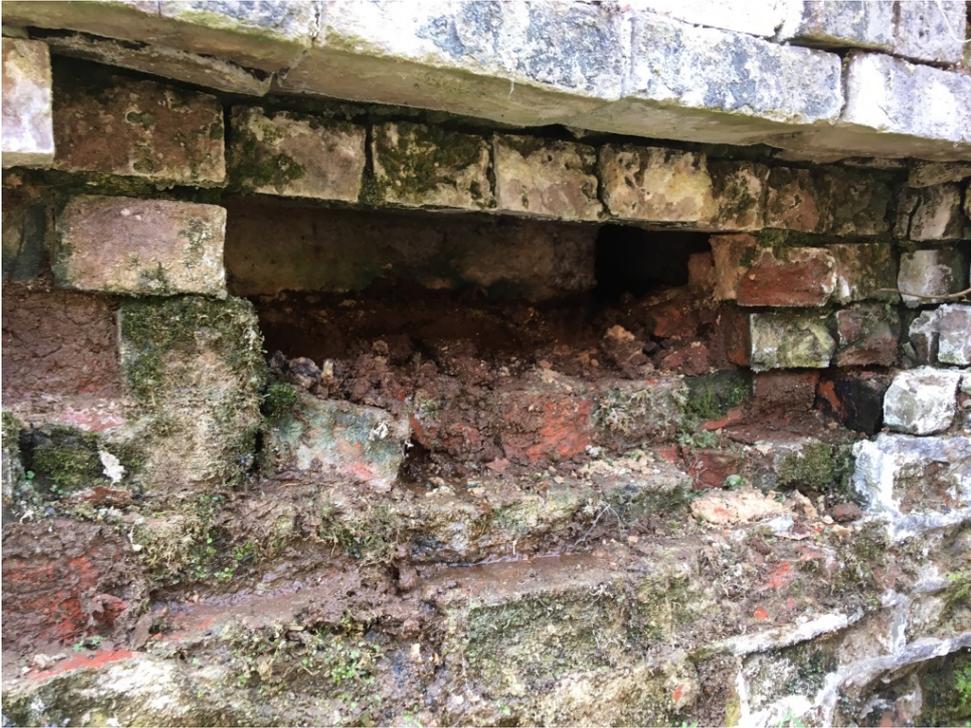
Area 2 – damage at level of horizontal timber. The timber had no structural integrity and only existed as small pieces. Note ‘true’ mortar at rear of pocket (implies timber part of original construction). Note also void at right hand end of pocket perpendicular to wall face and of some depth – presumably a void left by the complete disintegration of a horizontal timber member

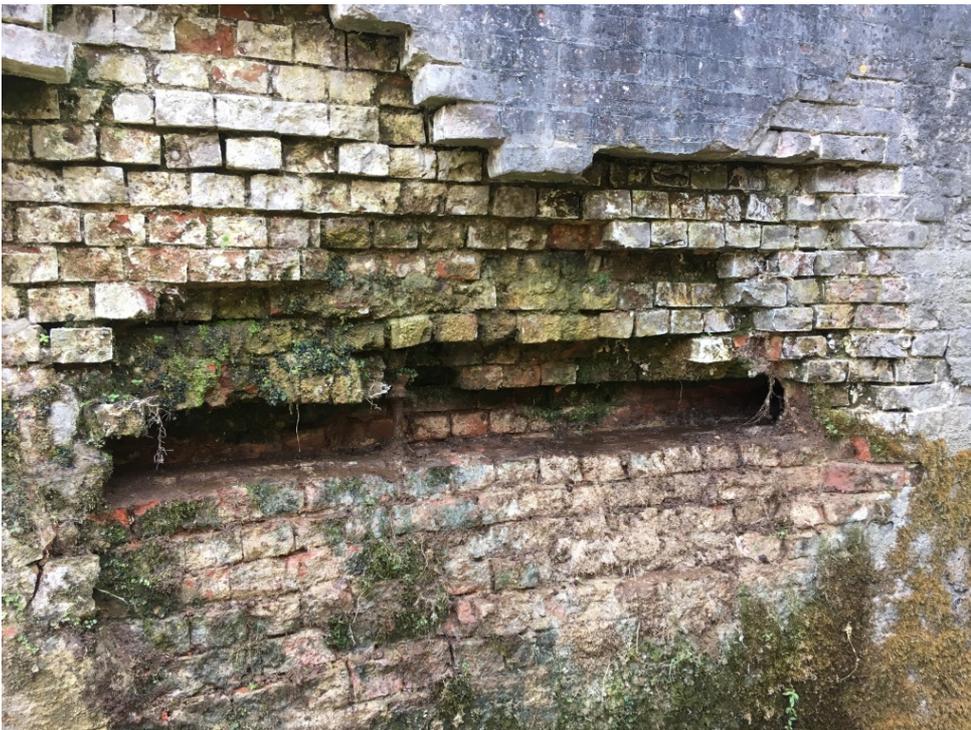
Area 3 – The timber was not really evident at all – horizontal void through to Area 2 and also towards area of top gate. Surviving iron bar that was originally through timber and passes above and below into original brickwork. Timber approx. 300mm behind current brick face (say approx..200mm behind original face of wall and therefore built within the original wall)

Given the above it was considered that a long lasting repair would involve more than simply replacing the facing bricks and a little local patching.
