NORTH WALSHAM & DILHAM CANAL TRUST

Subject: Bacton Wood Lock Work Party Report

Date: Saturday 19th, Sunday 20th, Monday 21st, Tuesday 22nd, Wednesday 23rd January

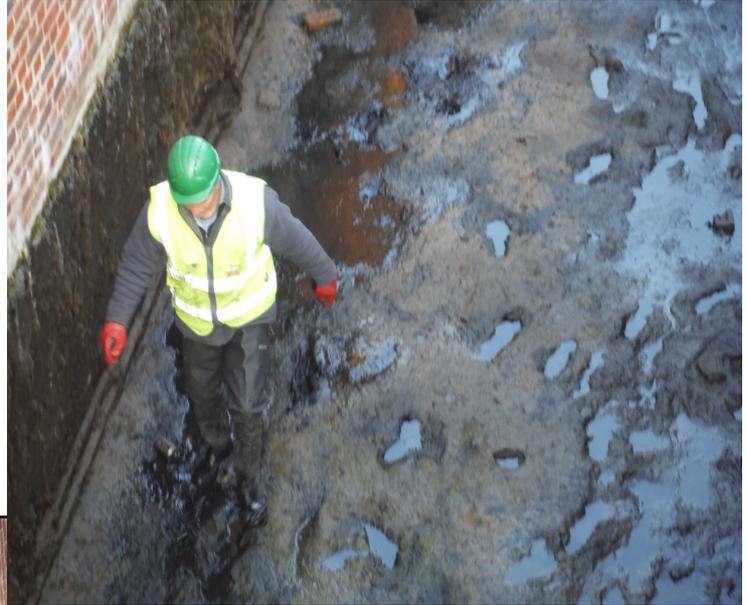
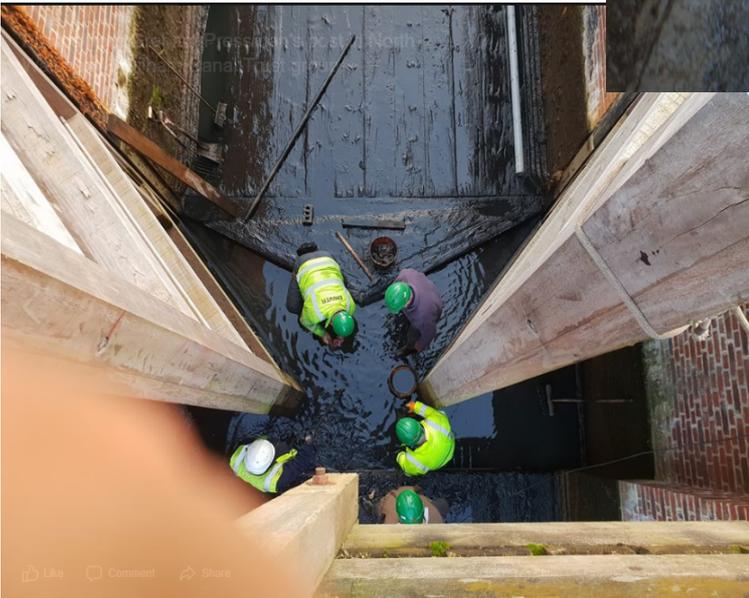
Photo below was taken by Graham Pressman capturing a unique view of the Bacton Wood Locks wooden floor.

Volunteers met up at the lock and pumped out all the water, removed all the planks, bricks and other debris that had been thrown in. Cleared all dog crap from around lock edges. Got site ready for the Sunday work party.

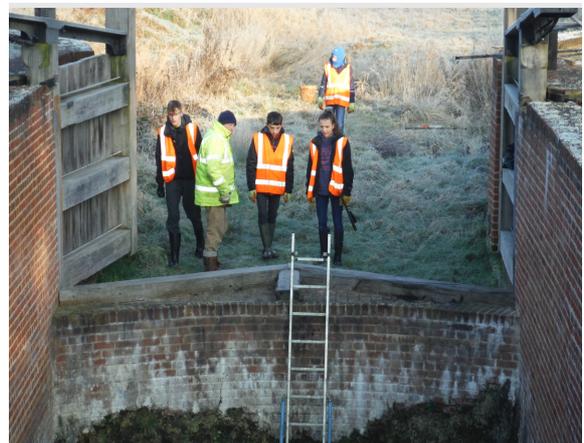
Volunteers met up at the work shop and distributed safety equipment to Duke of Edinburgh students and warned them to keep away from lock edges due to the icy conditions. They then cleared all scaffolding, bricks and other metal work from the entrance above the lock and also cut down willow growth in the same area with the help of Sue Kirrage, the Trust's Education Officer, keeping an eye on them. Once the lock was pumped dry again the main volunteers erected the scaffolding tower in front of the gates ready for the chain saw man to do his bit on Monday. The steel bands were then cut away from the base of both of the gates so as to allow cutting of the door edges. The

gates were then adjusted to get free movement, the gate on the path side was found to be binding in various places. Concrete that had been put down as a bodge job decades previously had to be removed with a Kangol drill to get free movement. But on opening gate fully to wall it was still fowling, so the bottom of the post was cut of using chain saw. This gave full movement. Scaffolding was moved to centre of lock for overnight security and the site was cleared of any thing that could have been thrown in overnight.

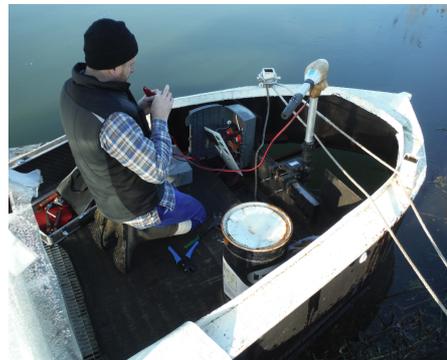
Trust Electrician Darren and the Electrician's mate worked upgrading Ella's electrics. First a new plug and socket system set up to make it easier for the crew to attach and detach the electric motor. Then a new fuse board and ancillary switch board wired in, with wiring provision for the headlight. Finally, the bilge pump electrics were re-routed with new switch gear.
