Date 27th and 28th September 2018

Improve the capacity of the Ebridge spillway

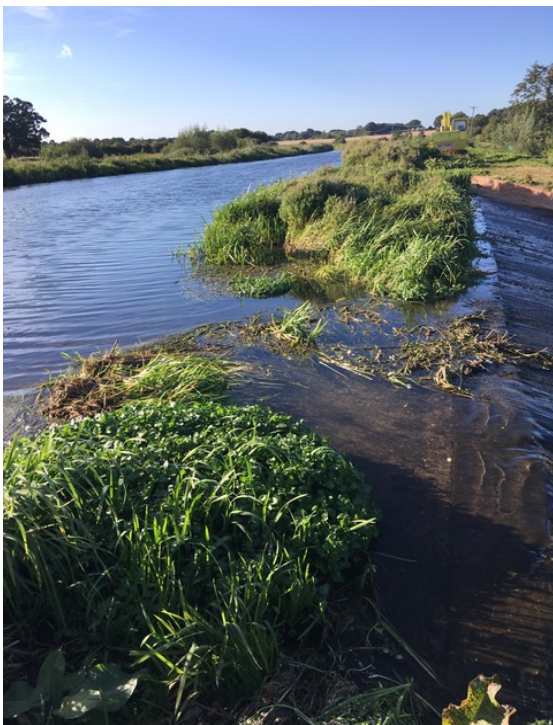
Before

Remove the vegetation from the bund above the water level. Remove the reed from the south end of the bund where under water. Reduce the level of the bund in the centre and northern end of the spillway

There were five volunteers on the Thursday. A brush cutter was used on the bund above water level and vegetation removed to the canal bank. The reeds were pulled from the southern end of the bund and similarly removed to the bank. The exiting channels in the north end of the bund were dug out (hopefully returning the capacity of the spillway to that of last winter). Excavation of the northern end of the bund was commenced.

On Friday 28th there were up to six volunteers but not all could work a full day. The majority of the remaining bund was reduced to below water level (i.e. the level of the top of the spillway.) Unfortunately, being a little short of manpower meant that a small part of the bund remains. The capacity of the spillway should not be too adversely affected by the 'island' but it would be good to reduce all of the bund to below water level at some time in the near future, for aesthetic reasons.
