# North Walsham and Dilham Canal Trust. Mitigation & Compensatory Plan- Section 2

Covering that section owned by the Old Canal  
Company Ltd. (OCC) which runs from Swafield  
Road Bridge to 20m below Ebridge Lock No. 3.

Prepared by the North Walsham & Dilham Canal Trust  
Mitigation & Compensatory Group

September 2020

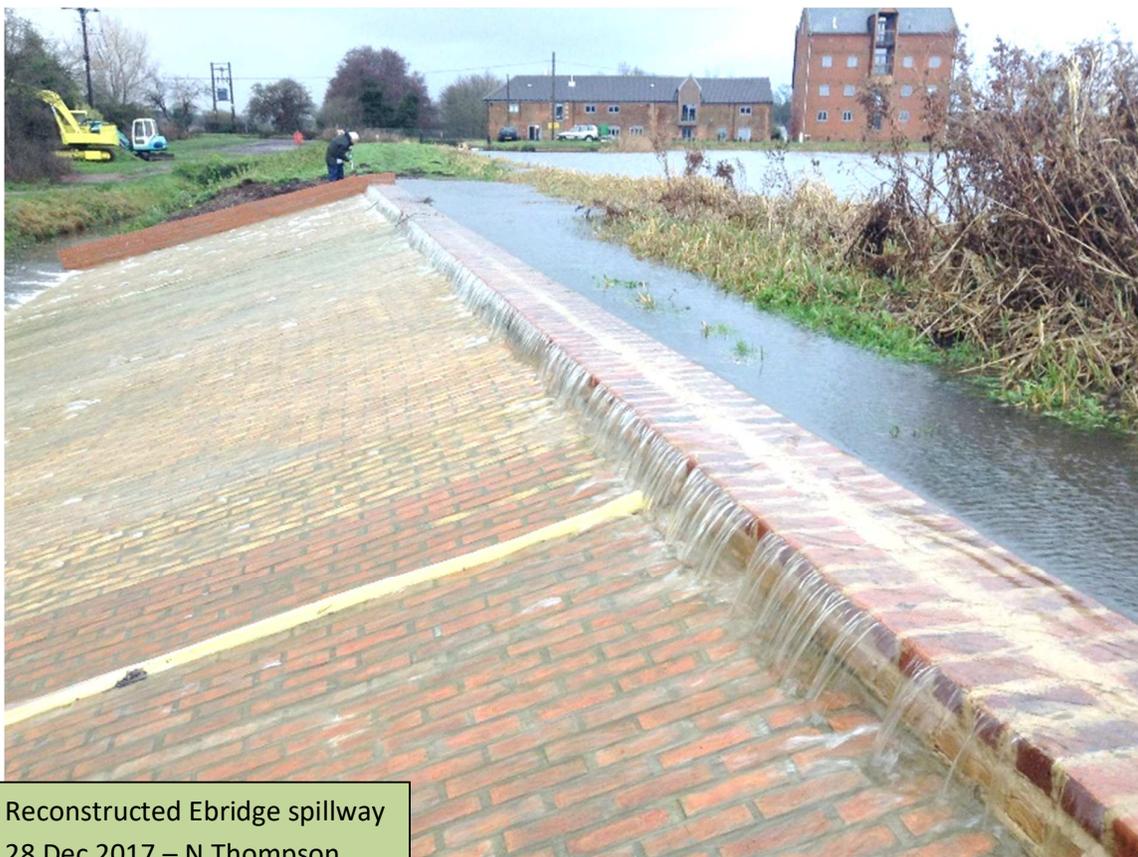
Reconstructed Ebridge spillway  
28 Dec 2017 – N.Thompson

The Ebridge spillway drain had been compromised by a partial collapse adjacent to the road bridge, for some 20 odd years. Following negotiations with the Norfolk County Council Highways and Bridges, the IDB, EA and OCC, an arrangement was made for the Trust, in co-operation with the OCC, to repair the damaged culvert and backfill the hole. This was completed on 1<sup>st</sup> March 2020. At the same time, the NCC Highways cleared the blocked drains, that had been installed some ten years earlier in an attempt to prevent run-off, in times of heavy rain, from the road into the hole.

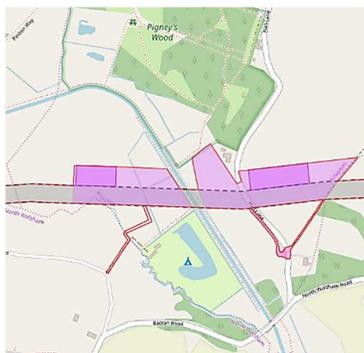
Vattenfall's proposed underground cable corridor from Happisburgh to Necton is also planned to pass under the OCC's section of the Canal, just above the Royston penstock. ( *Left - Vattenfall Maps 16 June 2017*).

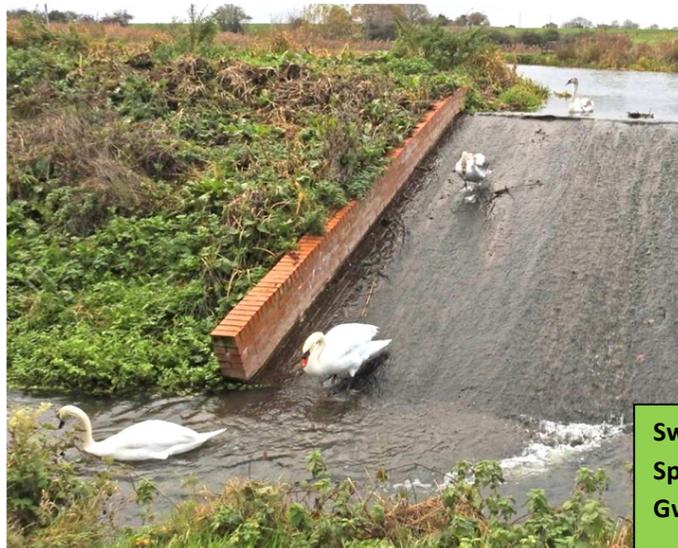
Swans making use of Ebridge Spillway, re-built 2017. Photo Gwennie Nunn, November 2018.

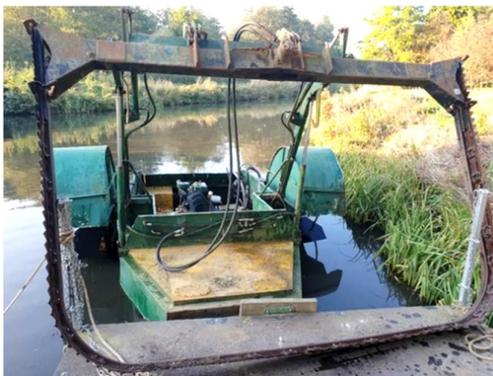
**Weedcutter,  
tractor,  
mower.  
Provided by  
North Norfolk  
District  
Council Big  
Society Grant**

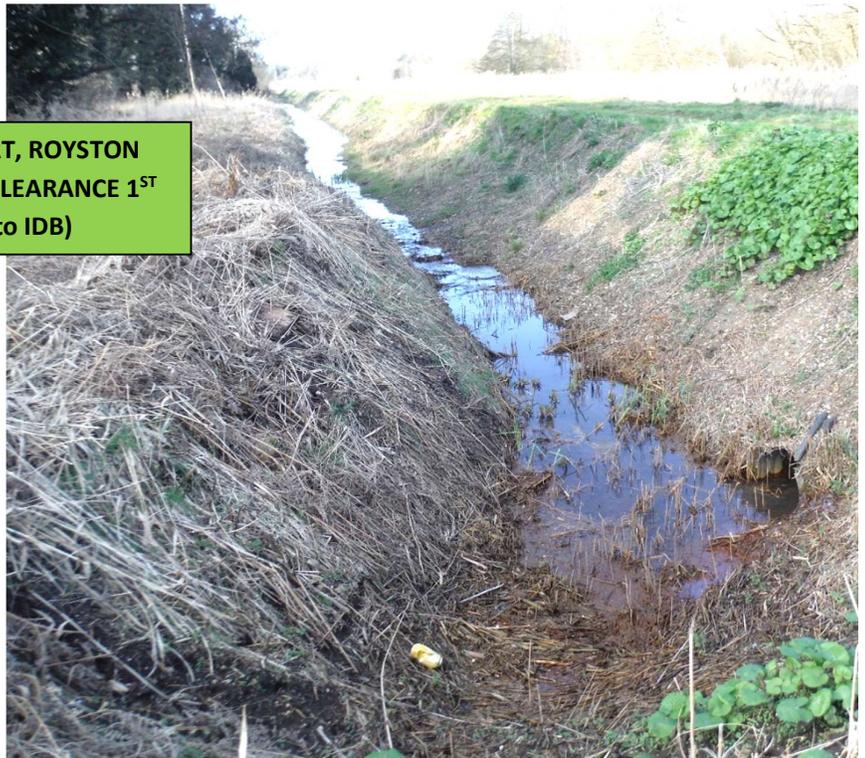
**WEST SOKE AND CULVERT, ROYSTON  
BRIDGE FOLLOWING IDB CLEARANCE 1<sup>ST</sup>  
MARCH 2020 (photo IDB)**

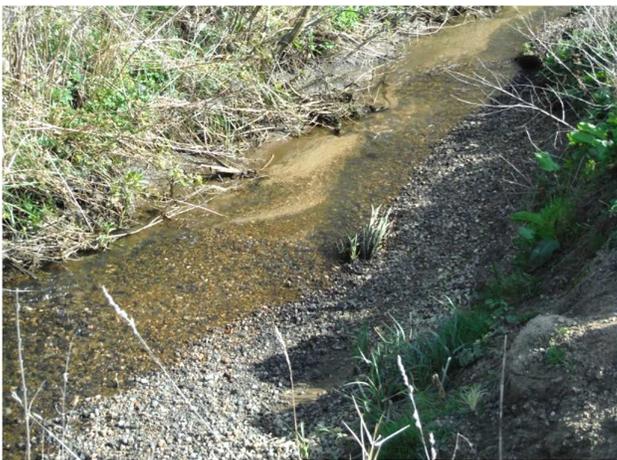
**Gravel bed Purdy's Marsh**

It is possible to use these drains for mitigation as they emulate a medium/ fast flowing stream, often with a gravel bed and in some cases goods quality water, which provides another habitat type to complement the restored Canal. At times these streams will carry high flows of water and need to be maintained with this primary purpose in mind. However, minor natural obstructions (e.g. fallen branches) can be left in situ where

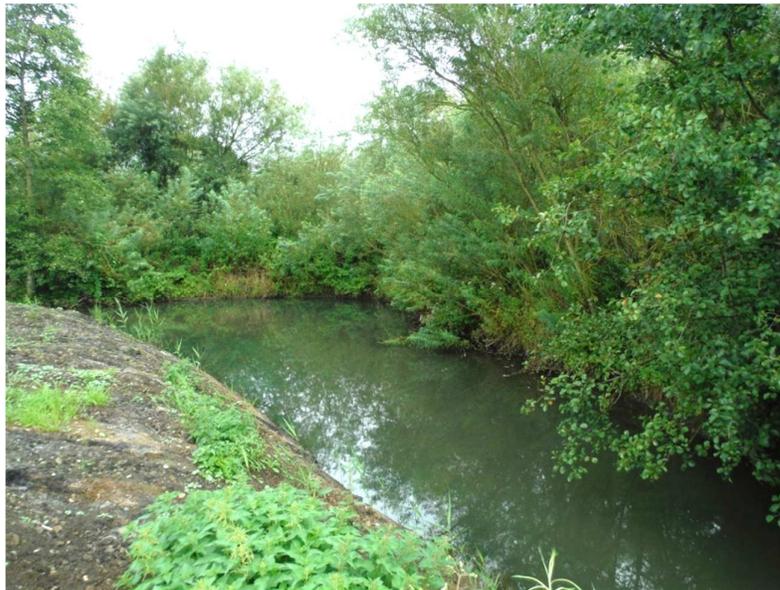
The Executive Summary the EA's Biology survey specifically mentioned the ponded section formed by rainwater to the north of Royston Bridge. It is described as a 'good quality pond, possibly of Biodiversity Action Plan Priority Habitat Status'. The report recognised that the pond was temporary, but it would be an excellent mitigation project if this pond was moved, as it will be lost when the canal is fully re-watered. A site for an alternative pond on the other side of the east bank has been identified by the OCC and they are currently clearing the land bounded by the Bacton road, Pigneys Wood road, the east canal bank and the east back soke.

The new pond, see the diagram next page, is to be created here, connected to the east back soke but having a gradual shallowing bed sloping towards the east soke. This new pond will be only a few metres from the 'temporary pond', should be able to replicate

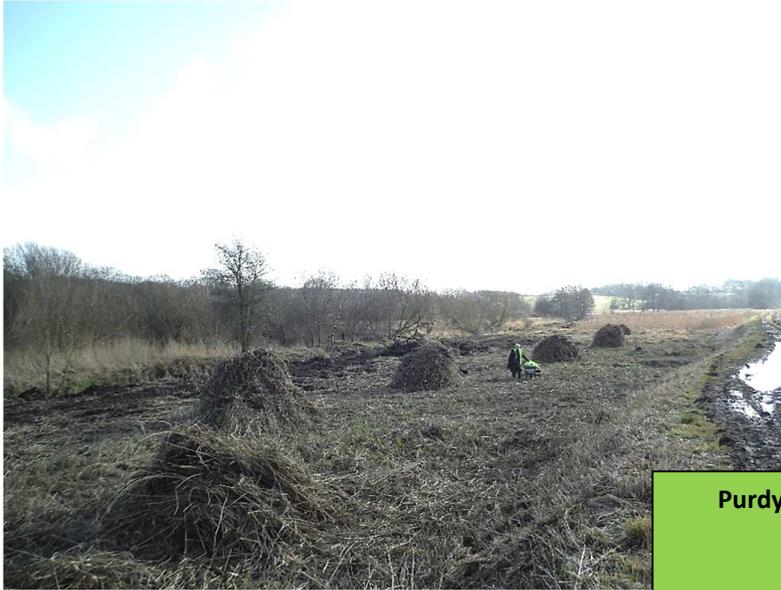
Purdy's Marsh vegetation clearance

Restoration of this area (see below) has been ongoing for five years (**see appendices 2a & 2b Purdy's Marsh**) and we see the overall project as having a very high mitigating value **H+**.

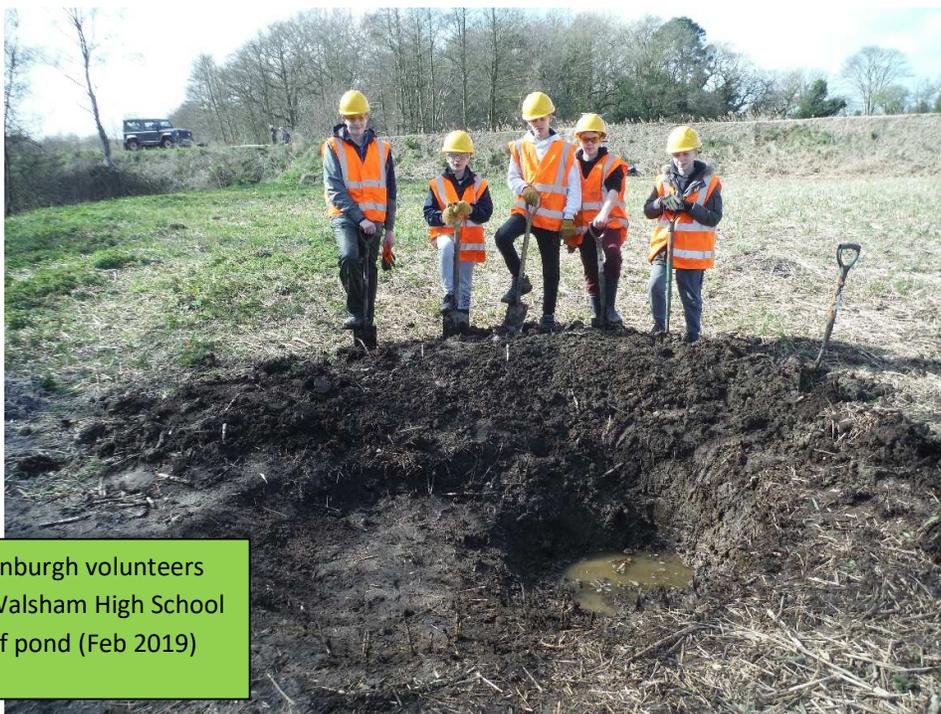
Duke of Edinburgh volunteers  
from North Walsham High School  
digging turf pond (Feb 2019)

There is further scope for mitigation within the Pigneys Wood Nature Reserve as it adjoins the canal corridor for some considerable distance. It is now managed by the Norfolk Wildlife Trust and the NW&DCT has already suggested that it support and help to enhance an area near the canal. Our first joint efforts with the Norfolk Wildlife Trust (NWT) involved the formation this year of shallow turf ponds or 'scrapes' in Purdy's Marsh. This is regarded as a high mitigation value project **H** and one capable of more development over the years.

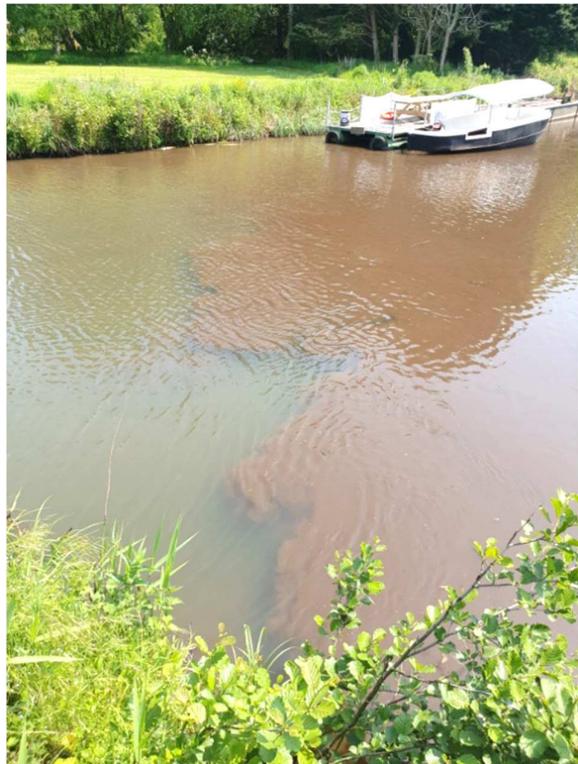
- a) Two broad boats, each drawing 2ft.
- b) A broad boat at full draught and a 9ft boat drawing 2ft.

Given 1:2 channel sides the surface width required is 30ft in general in cases (a) and (b). Allowing for 2in fluctuation of water level due to differing flows over the by-wash weirs gives 30ft width at NTWL. In places the Canal will be wider, due to passing places, staithe, turning areas as per the 1812 Act (up to 60 feet), in others less due to natural features.

3ft 3in draught vessels require more water depth than 3ft 3in to prevent grounding on chance debris and to minimise turbidity. A depth of 4' 6" (as per existing sill depths) is a sensible post-de-silting norm, since North Walsham & Dilham Canal was probably not clay-puddled for part of its length.

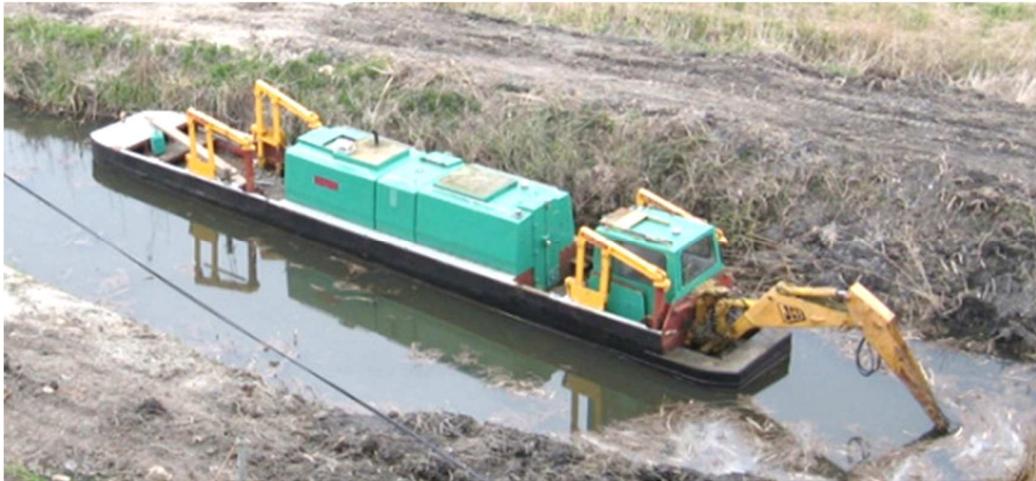
**The Trust has just taken a long lease on the ex-British Waterways dredger "Weasel."  
January 2020**
