In co-operation with the East Anglian Waterways Association Ltd

Subject Reduce height of Ebridge spillway/examine breaches above Ebridge Lock

Date 3rd April 2018

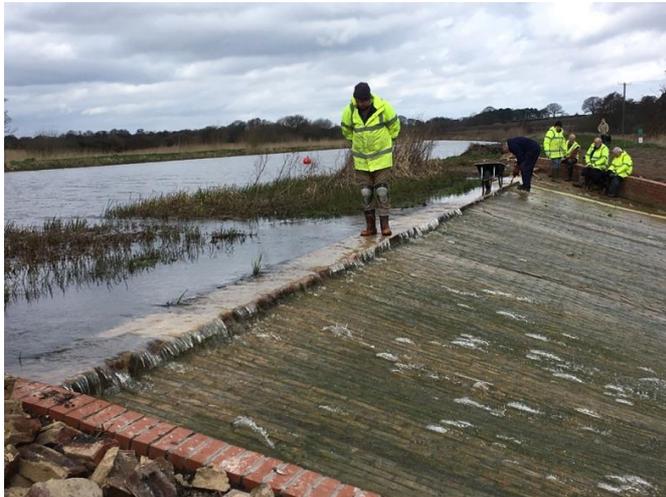
The top level of bricks (placed there by the WRGies last summer using mortar that had lime in it) was quickly removed. The paddle was closed and the water flowed over the spillway (and still over the lock).

One layers of bricks removed

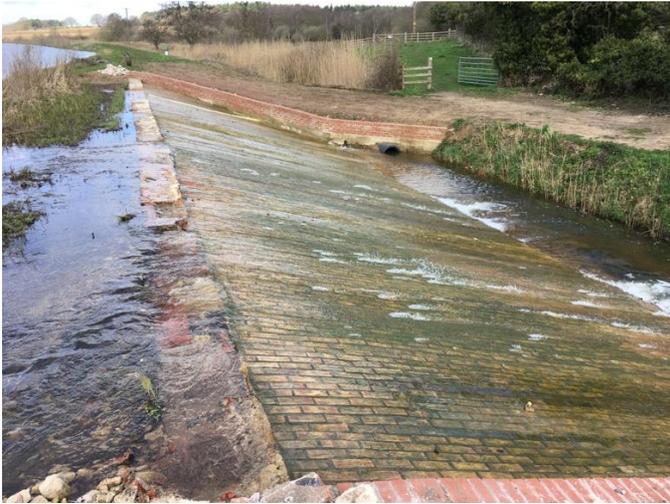
This proved considerably more difficult with hand tools as there was more cement based mortar over some of the length of the spillway. The layer was only partly removed when work ceased at 1300hrs but it was believed would provide some control of the level unless there was significant rainfall.

2nd layer partially removed – flow over spillway the following day

GP would continue to monitor the level of the water until the Sunday work party could complete the removal of the second row of bricks. A further assessment can be made at that time. Better power tools would make this task easier (eg a Kango hammer or similar).

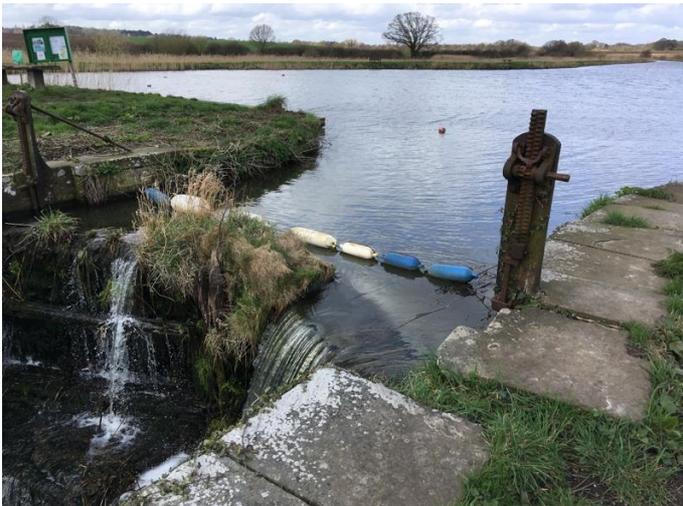
Flow over lock the following day
